Inspection Report Minerals Regulatory Program June 24, 2013

Mine Name: Black Sands 47278	Permit Number: S0470085
Operator Name: Black Sands Holding Co.	Inspection Date: 06/18/2013
Inspector(s): Tom Nicolaysen (intern)	Time: 1:30 PM
Other Participants:	Mine Status: Inactive

Inspection of reclamation for bond release

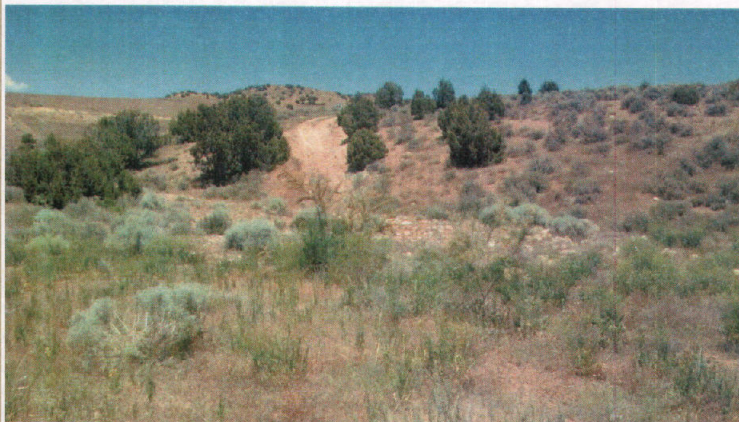
Site of the first drill hole looking east from the road. Substantial re-vegetation on the drill pad. UTM NAD 83 E 616147.72, N 4476227.60

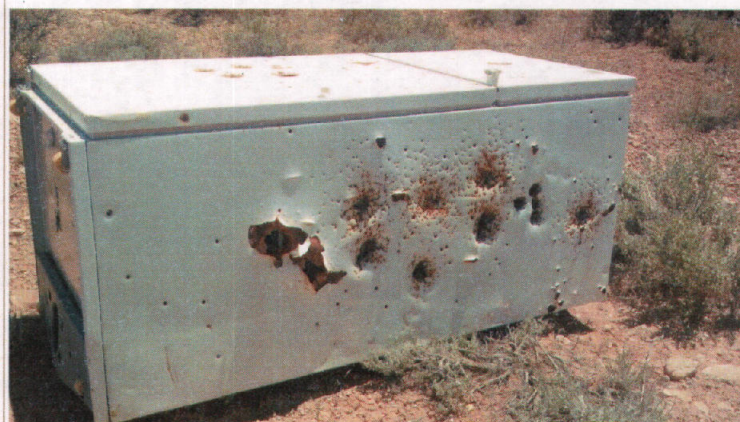
Regraded and some re-vegetation. Some trash was found on site including a junked refrigerator. No drill holes were found on the site which suggests they may have collapsed.

Junked refrigerator on the hill by the road just above the first drill site.

The site is released from bond after trash is removed.

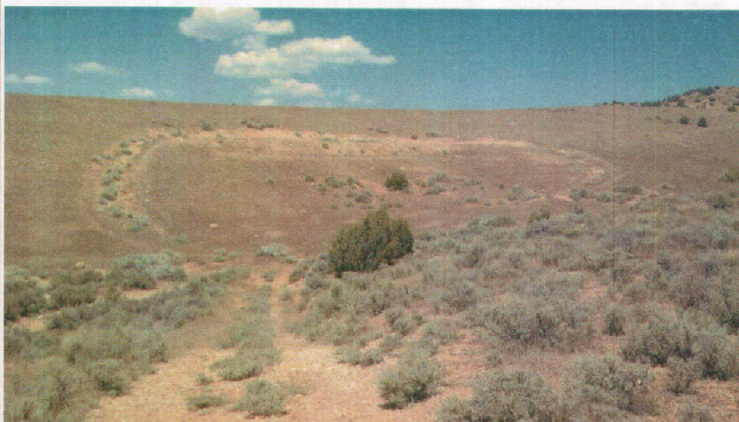
The second drill site, over the hill east of north east of the first site, has been re-vegetated. Traces of the road remain but no further action is recommended. UTM NAD 83: E 616204.50, N 4476415.22

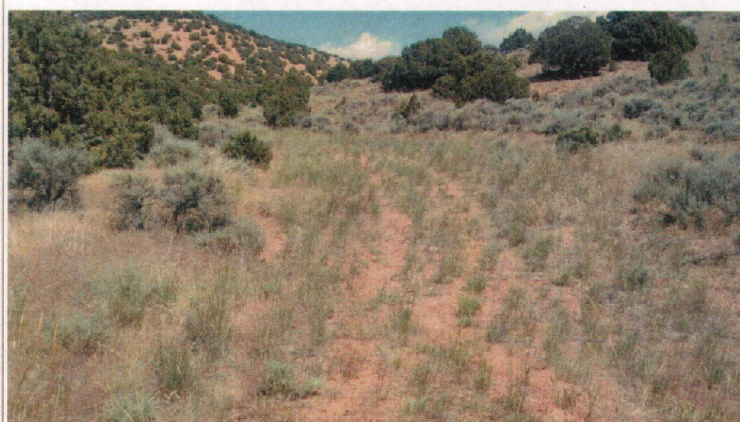
The third drill site is sufficiently re-vegetated and no further action is necessary. UTM NAD 83: E 617208.03, N 4476448.52
